# **Screw insertion in trabecular bone causes peri-implant bone damage**

Juri A. Steiner<sup>1</sup>, Stephen J. Ferguson<sup>1</sup>, G. Harry van Lenthe<sup>1,2</sup>

<sup>1</sup>Institute for Biomechanics, ETH Zurich, Vladimir-Prelog-Weg 3, 8093 Zurich, Switzerland

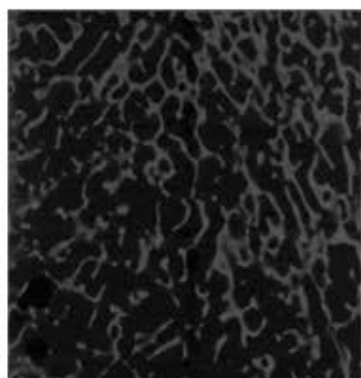
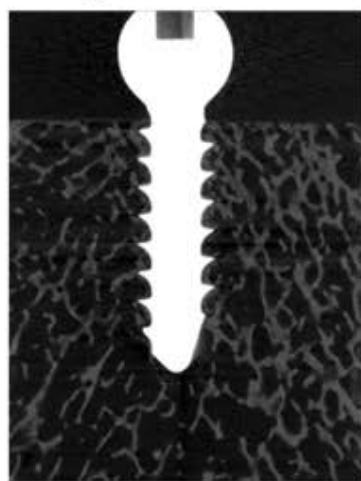
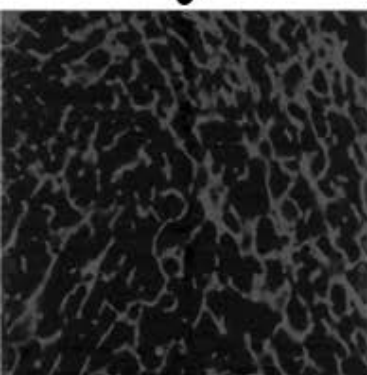
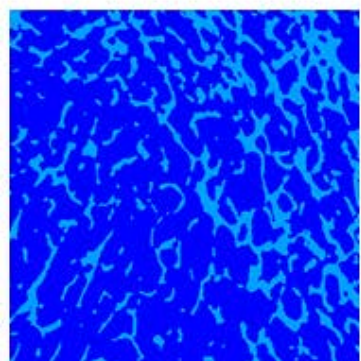
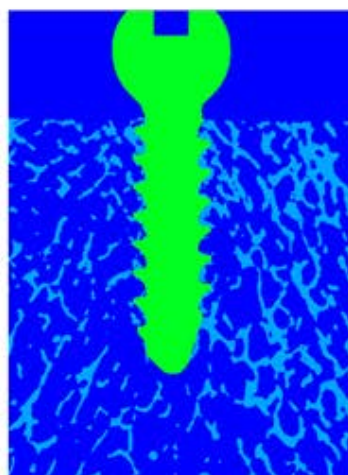
Fig. 1: Peri-implant bone damage was assessed by conducting two sets of  $\mu$ CT scans; once before and once after screw insertion. Image registration was used (step a) to align  $\mu$ CT scan 1 with  $\mu$ CT scan 2 (step b). Next, both grey scale images were segmented to obtain the bone and screw structures (step c). In the last step (d), the segmented screw from the physical insertion (PI) model was copied and digitally inserted into the segmented image of  $\mu$ CT scan 1 to obtain the digital insertion model; the latter does not contain any peri-implant damage.

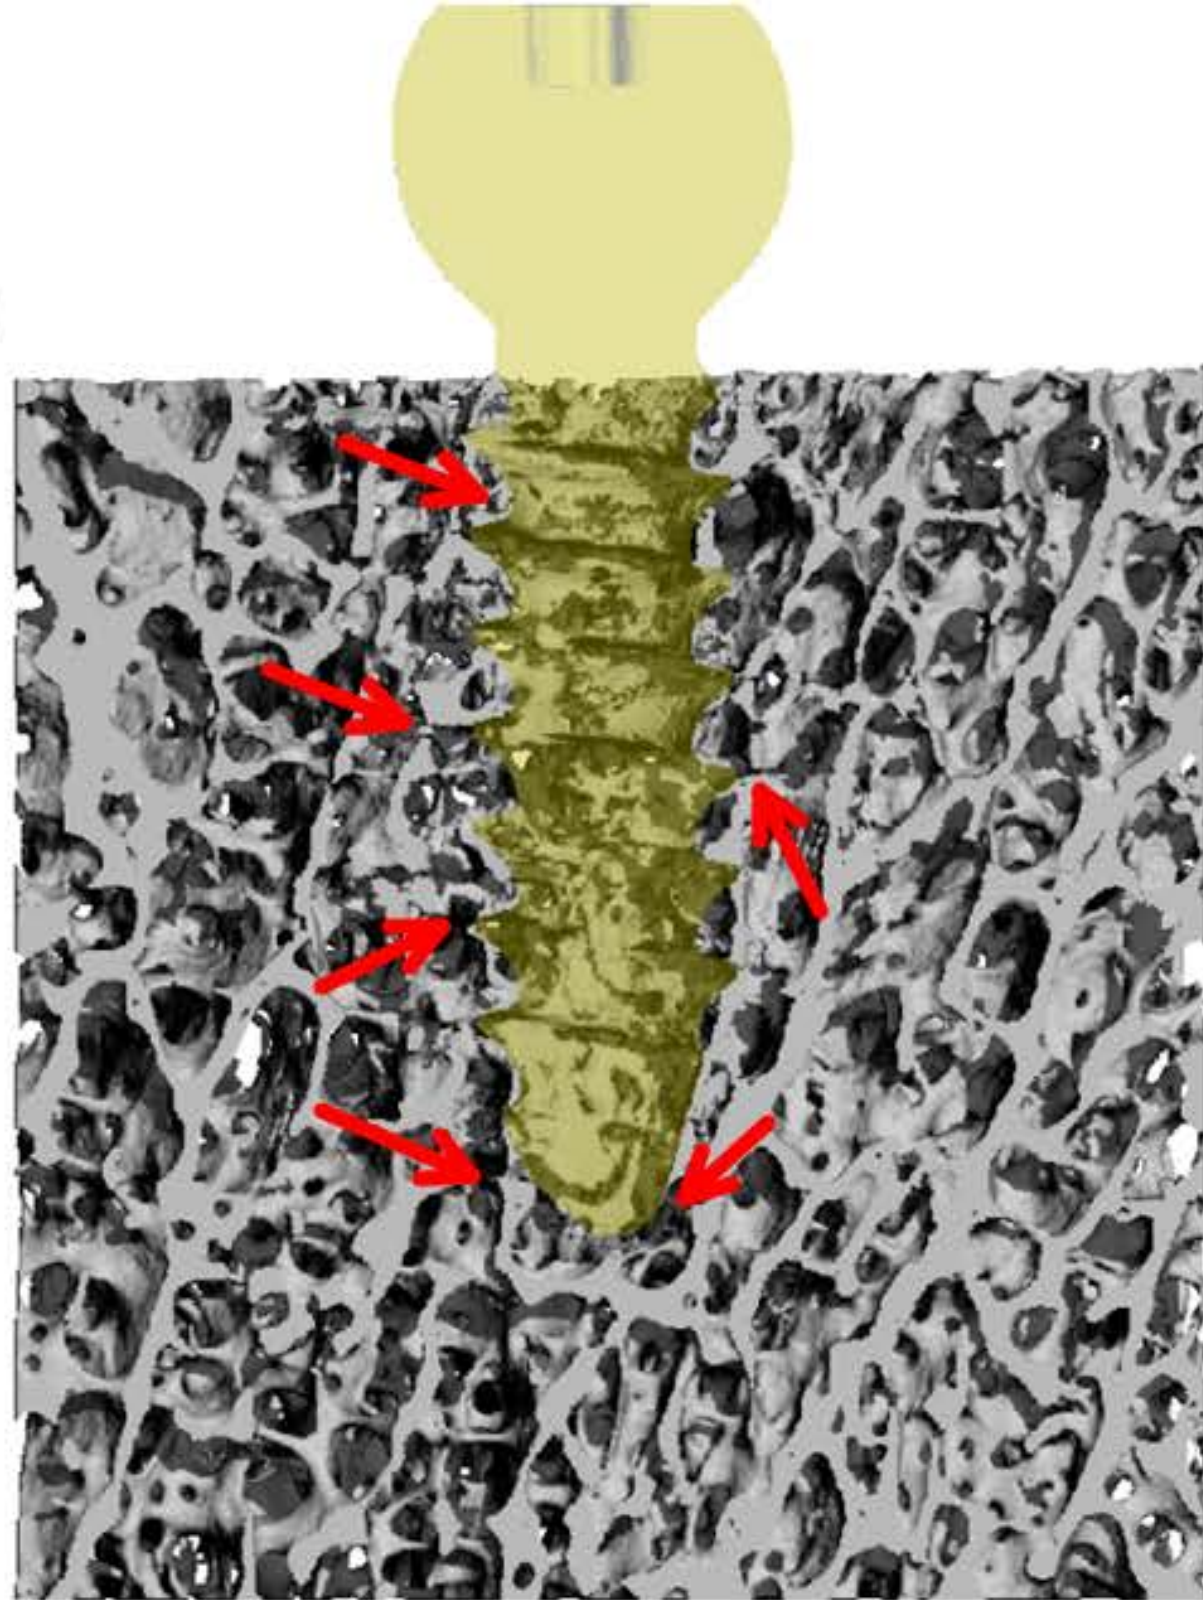
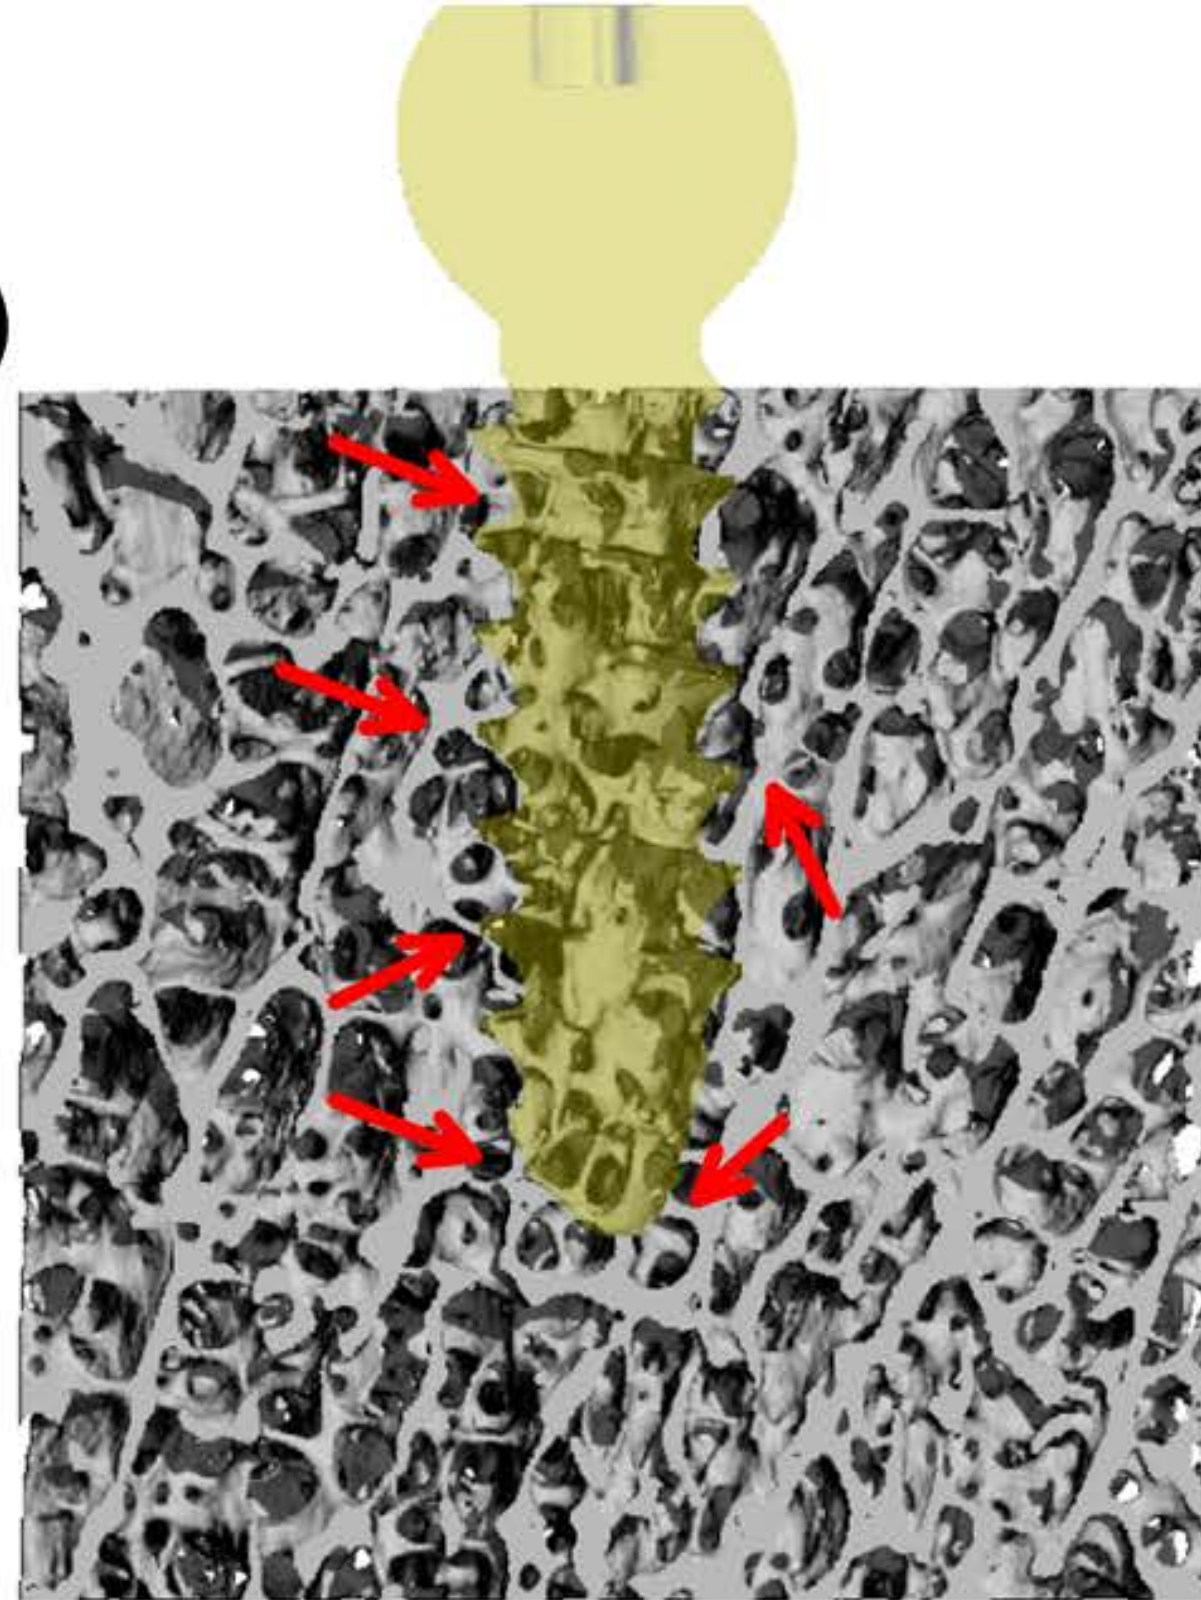
Fig. 2: The images on the left and right side show representative examples of a physical insertion (PI) and a digital insertion (DI) model, respectively. A visual comparison between the PI and DI model showed clear evidence for peri-implant bone damage due to screw insertion (representative locations shown with red arrows).

A visual comparison between the PI and DI model showed clear evidence for peri-implant bone damage due to screw insertion (indicated by red arrows in Fig. 2). Further visual assessment of the computed bone damage revealed a clear densification of BDD towards the implant site (Fig. 5a and 5b). For the STS group, BDD was significantly higher than the precision up to 0.6 mm distance from the screw (Fig. 5c). For the LTS group significant differences were found up to 0.9 mm radial distance from the implant (Fig. 5d). In both groups, we could observe that with increasing distance from the screw, BDD quickly converged towards the precision level (Fig. 5c and 5d). The LTS group showed significantly higher BDD values than the STS group in the VOIs between 0.3-0.6 and 0.6-0.9 mm distance from the implant. Highest BDD values were found in the VOI closest to the implant; no significant differences in BDD were found between the STS and LTS groups. The average BV/TV over all specimens is  $27.2\% \pm 4.1\%$ . BV/TV for the STS and LTS group was  $25.8 \pm 1.9\%$  and  $29.0 \pm 4.6\%$ , respectively ( $p=0.064$ ). Within the VOIs where BDD was significantly higher than the precision, BV/TV shows no significant correlation to BDD in both groups ( $R^2 < 0.4$  and  $p > 0.05$ ).

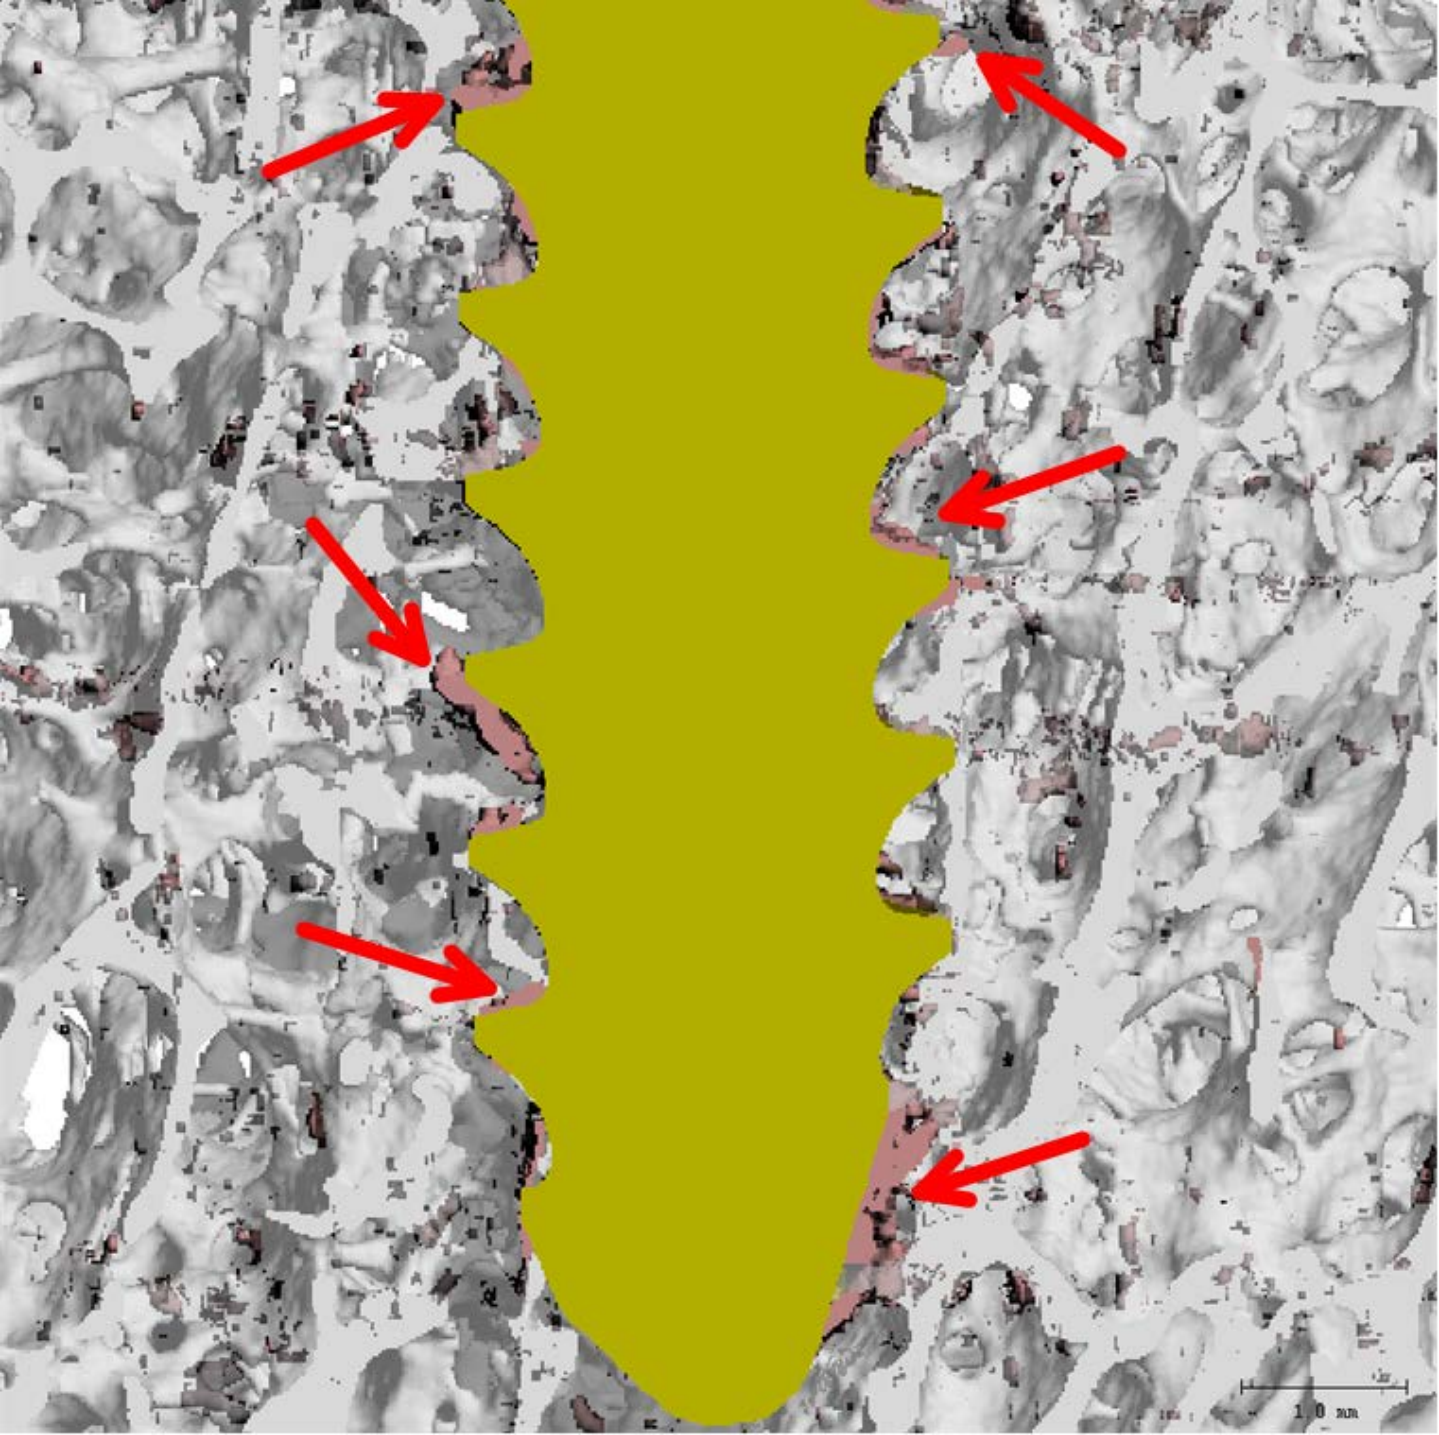
Fig. 3: In an overlay procedure, the digital insertion (DI) and physical insertion (PI) image were combined to produce an overlay image. In the overlay image, two specific voxel-labeling categories were defined: (1) bone present in both images (transparent grey) and (2) bone present in the PI image only (pink). The bone in category 2 represents bone that has been displaced due to pre-hole drilling and screw insertion remains within close vicinity of the screw. The red arrows point out representative locations.

Twenty cylindrical trabecular bone specimens (18 mm height; 16 mm diameter) were core drilled from the epiphyseal region of twelve cadaveric human femoral heads (age  $66.5 \pm 10.5$  years). After predrilling with a diameter of 2 mm, one self-tapping screw (length: 16mm; core diameter: 2.1 mm) was inserted 11 mm into in the center of each specimen according to the manufacturer's guidelines. Two thread sizes, defined as  $0.5 \times$  (outer diameter – core diameter), were used. The small thread size (STS) and large thread size (LTS) were 0.3 mm and 0.6 mm, respectively. The pitch sizes of the STS and LTS groups were 0.65 and 1.31, respectively. All specimens were scanned twice with micro-computed tomography ( $\mu$ CT50, Scanco Medical, Brüttisellen, Switzerland) using 90 kVp energy at a nominal isotropic resolution of 20  $\mu$ m; one scan was made of the intact specimen prior to screw insertion and another scan was made just after screw insertion. The screws were custom-made (DePuy Synthes, Solothurn) based on a Titanium-Aluminum alloy ( $\text{TiAl}_6\text{Nb}_7$ ) that contains a relatively low atomic number to reduce potential metal artefacts during scanning [25]. After image reconstruction, rigid image registration was performed, as described in recently published literature [26], to align the two images (Fig. 1a and 1b). Next, both images were segmented following well accepted guidelines [27] (Fig. 1c) based on visually distinctive grey scale values for bone and screw (arbitrary units: 200 to 400 and 800 and 1000, respectively). A visual check revealed no artificial gaps due to the segmentation. Next, the segmented screw from the physical insertion (PI) model was inserted digitally (Fig. 1d) into the image stack of the pre-insertion scan to obtain a digital insertion (DI) model. While the PI model represents the bone core with the physically inserted screw including the peri-implant bone damage (Fig. 2a), the DI model represents an idealized perfect insertion without any peri-implant bone damage (Fig. 2b). Bone debris at the outer surface of the bone sample, caused by sample preparation, was extracted by digitally removing a 0.5 mm ring of the outermost bone structure. Next, an image overlay was performed between the PI screw model and the DI screw model (Fig. 3). In the overlay image, two specific voxel-labeling categories were

defined: (1) bone present in both images (transparent grey in Fig. 3) and (2) bone present in the PI image only (pink in Fig. 3). The bone in category 2 represents bone that has been displaced due to pre-hole drilling and screw insertion and is quantified as the bone damage volume (BDV; Fig. 3). Bone damage density (BDD) was assessed by computing BDV normalized to the bone volume (BV) in hollow cylindrical VOIs around the screw ( $BDD = BDV/BV$ ) of the corresponding cylindrical VOI. All VOIs had a radial thickness of 0.3 mm; their inner radius was varied in steps of 0.3 mm (up to 5.1 mm) to describe different distances to the screw (Fig. 4a). BV divided by the total volume (TV) in which the BV is located, was computed to calculate the average bone volume fraction (BV/TV) over all specimens as previously defined here [27]. Furthermore, BV/TV was assessed within each hollow cylindrical VOI and correlated to BDD.

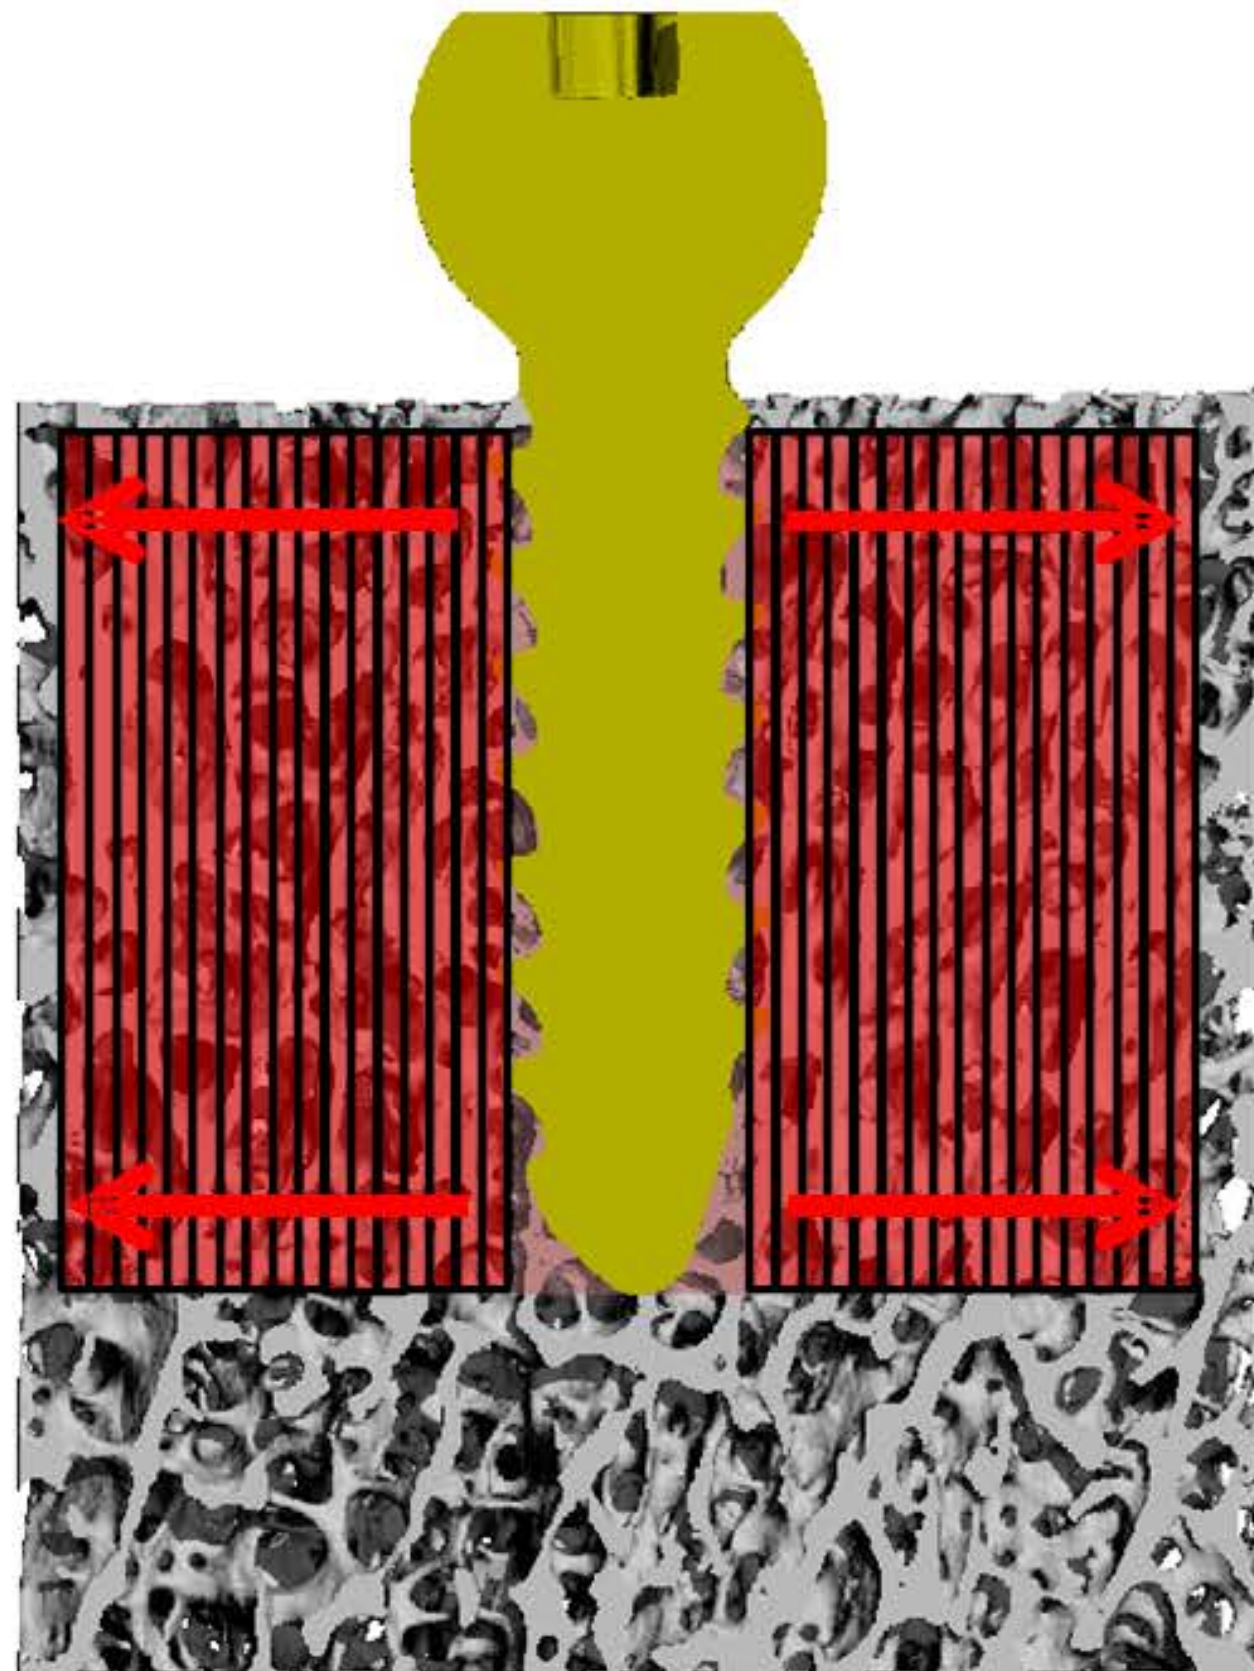
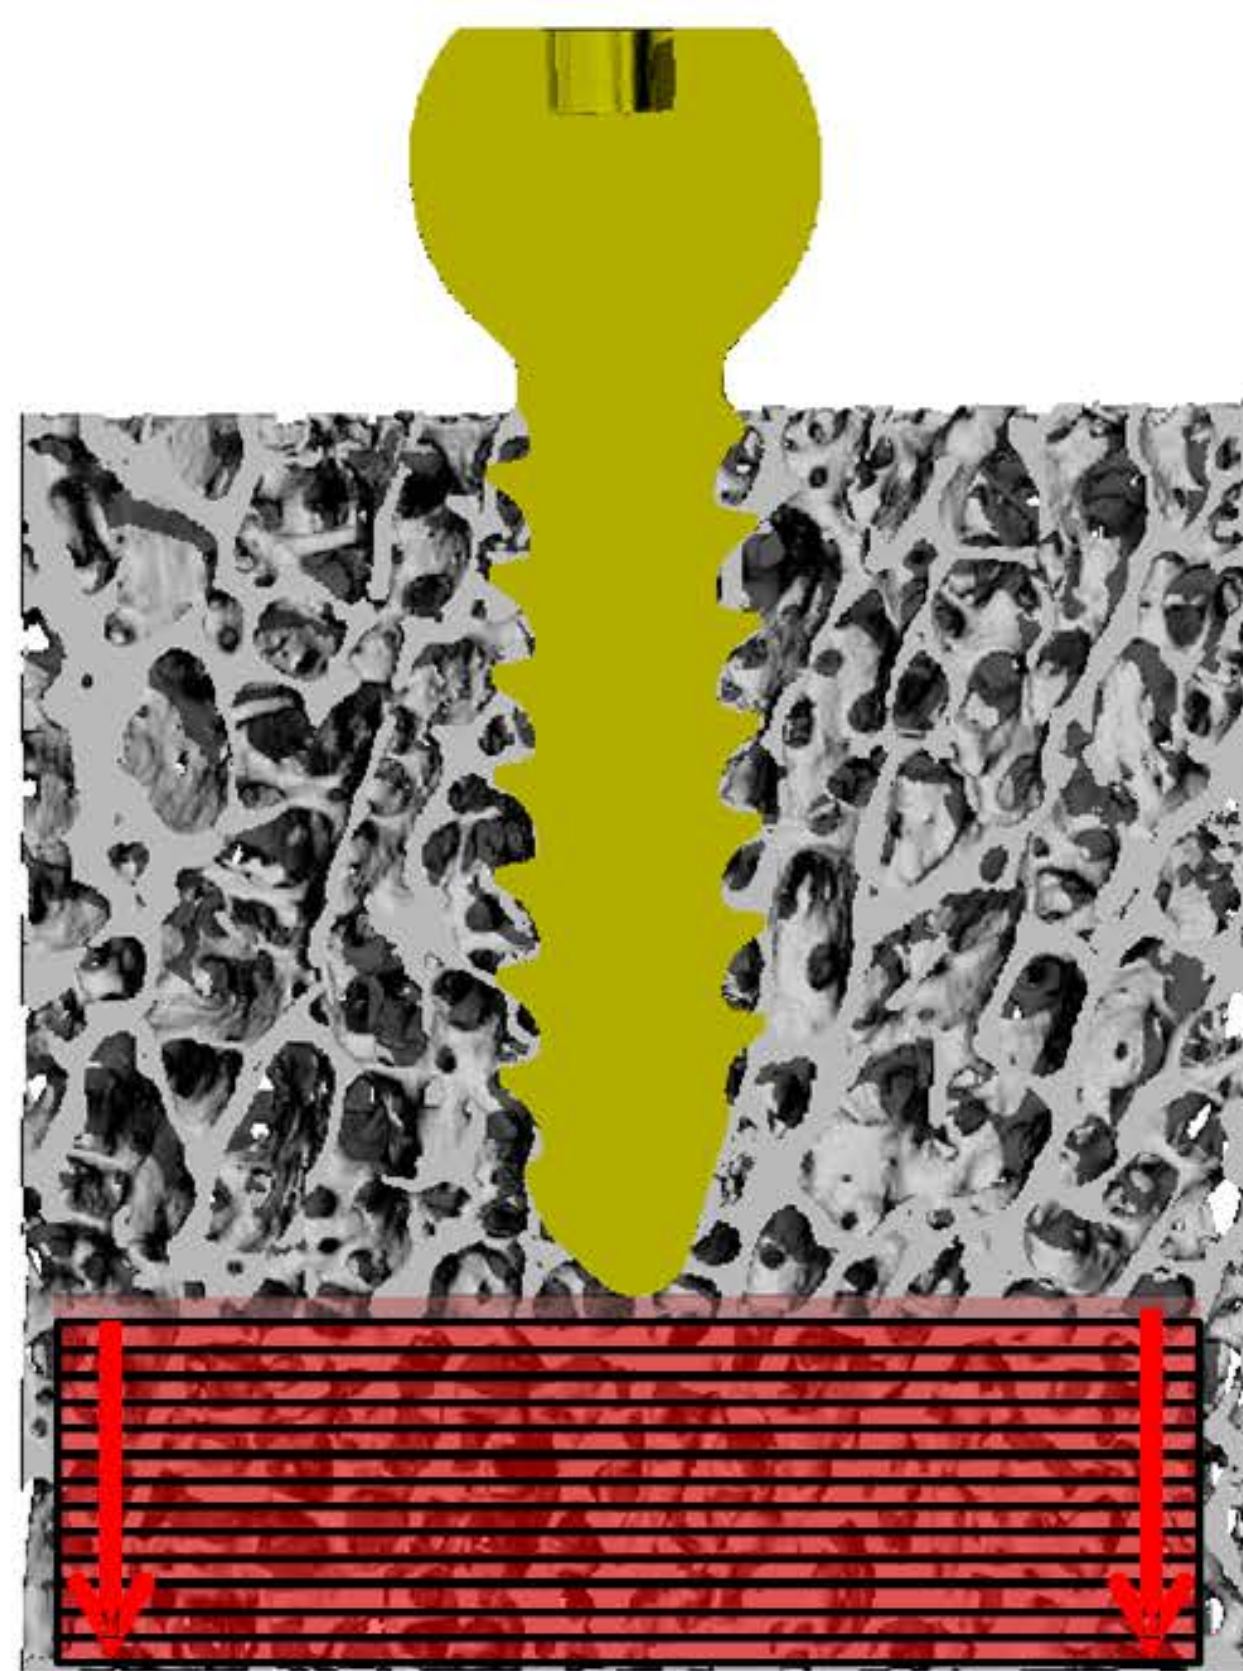
Fig. 4: The precision of the entire rescanning and registration process was assessed underneath the screw where no architectural changes were expected. More specifically, all bone voxels belonging to category 2 (Fig.3) were quantified in 14 cylindrical volumes of interest (VOI; all 0.3 mm in height and 5.4 mm in diameter) underneath the screws and normalized to the bone volume (BV) of the VOI (Fig 4a). Bone damage density was assessed in hollow cylindrical VOIs around the screw in a range from 0.0 to 5.4 mm in steps of 0.3 mm (Fig 4b) by computing bone damage volume (BDV) normalized to the bone volume ( $BDD = BDV/BV$ ).

Most measurement techniques contain a residual noise level (i.e. precision) even though in reality no signal exists. In our case, the precision of the entire rescanning and registration process was assessed underneath the screw where no architectural changes were expected. More specifically, all bone voxels belonging to category 2 were quantified in 14 cylindrical volumes of interest (VOI; all 0.3 mm in height and 5.4 mm in diameter) underneath the screws and normalized to BV of the VOI (Fig. 4b). The quantified precision from the region underneath the screw (Fig. 4b) served as threshold against which BDD values in radial distance to the screw (Fig. 4a) were compared to detect actual bone damage that is significantly different from the precision level.
